Whakarire Ave: Coastal Protection Works Workshop

The purpose of this workshop (held on 9th September 2014) was to investigate options that could be acceptable to both the Hawkes Bay Regional Council (represented by Richard Reinen-Hamill) and Napier City Council (represented by Stephen Priestley).

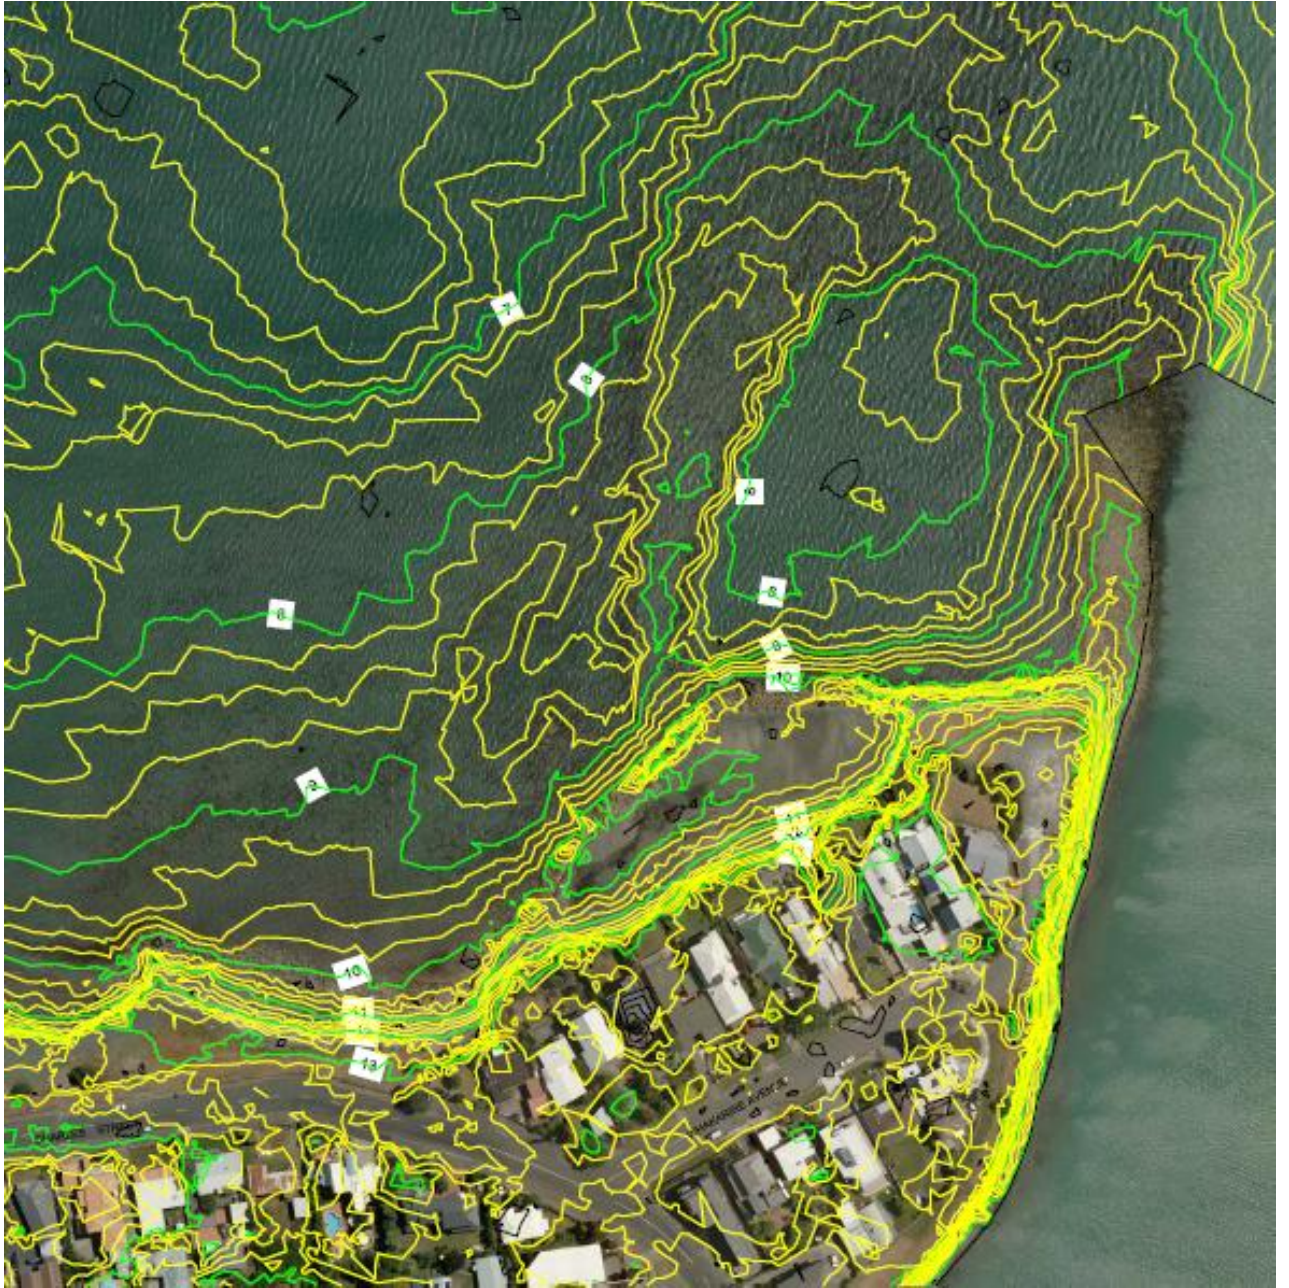
Figure 1: Existing Layout

(Survey datum to NCC)

- The extent of the works is from the revetment adjacent to the Western Mole of the Ahuriru Harbour entrance to the large concrete blocks on Westshore Beach.

- Existing ground levels seaward of Charles Street, in the Council Reserve and the revetment crest immediately west of the Western Mole are around RL 13.0m (i.e. 3.0m above mean sea level). The existing wall/breakwater has crest levels in the range of RL 11.5 to RL 12.0m.

Option	Refer Figure	Description	Consequence	Meets Objectives (See Section 2)		
1	1	Do nothing	Existing seawall will deteriorate further and there will be loss of land, particularly with sea level rise (SLR)	1	x	
				2	✓	
				3	x	
				4	x	
				5	x	
2	1	Maintain existing seawall	Status quo will remain. Eventual loss of land with SLR	1	x	
				2	✓	
				3	x	
				4	x	
				5	x	
3	2	Upgrade or modify end structures to existing wall to improve beach retention. Form a gravel beach along back of lagoon adjacent to reserve. Maintain as required.	Better public access. Extreme storms may result in loss of land.	1	x	
				2	✓	
				3	x	
				4	x	
				5	✓	
4	3	Perched beach within the lagoon. Upgrade or modify end structures to existing wall to improve beach retention. Low level back stop wall (buried) in Council reserve.	Good public access. High potential for re-development. Loss of some privacy for Whakarire Ave residents.	1	x

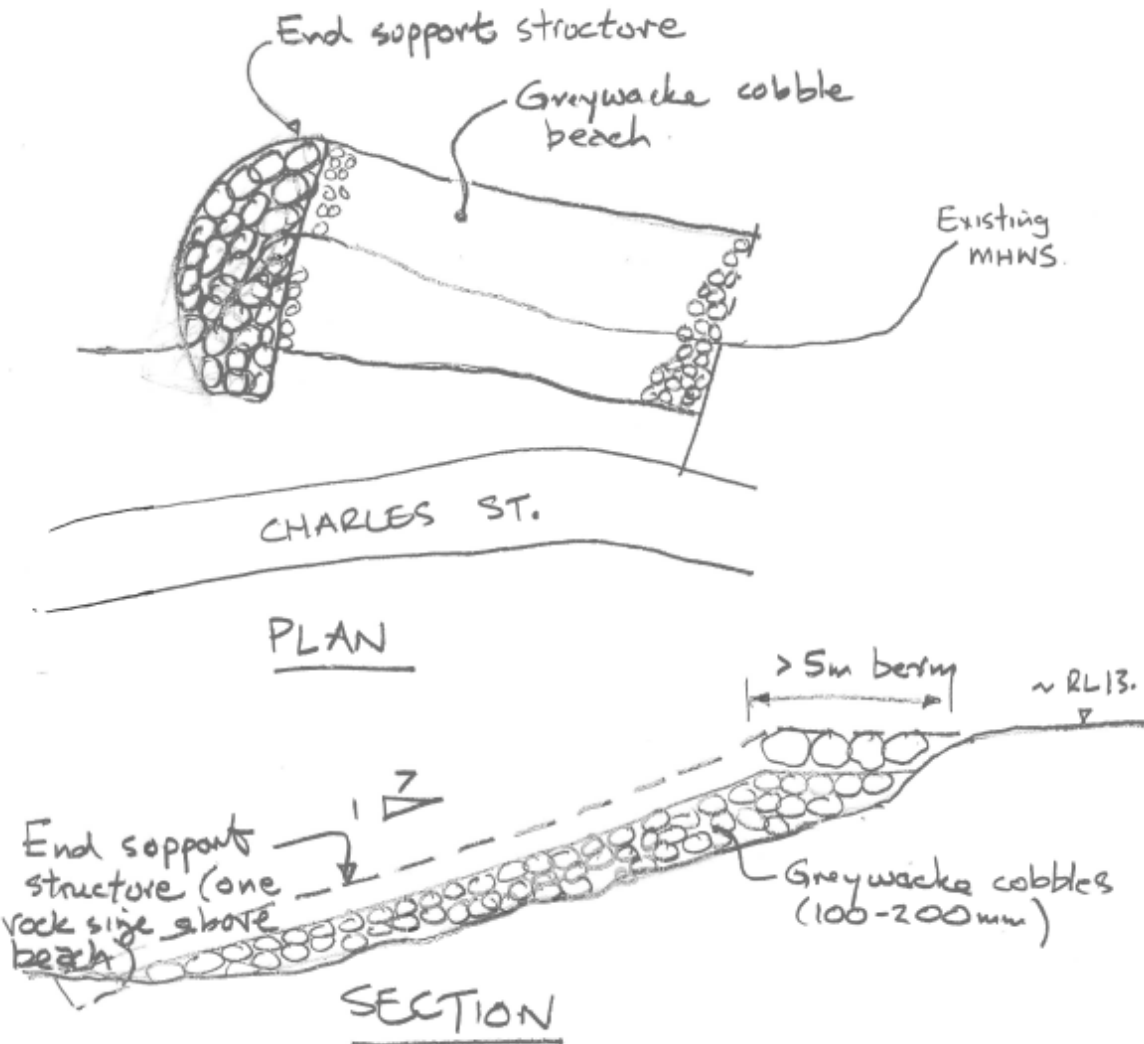
FIGURE 7

OPTION B

2	✓
				3	NA
				4	x
				5	✓
A		1:3 Revetment along Westshore Beach in the same fashion as Waimarama Beach.	Robust protection structure for Charles Road. Potentially could increase wave reflection and affect surf-ability.	1	✓
				2	x
				3	NA
				4	x
				5	✓
B		1:7 Wave spending beach with robust end structure.	Use greywacke cobbles to blend in with Westshore Beach. End structure would cover existing concrete blocks. Option would reduce wave energy extending onto Westshore Beach.	1	✓
				2	✓
				3	NA
				4	✓
				5	✓
