# **Damage to the Waiwhakaiho Reef Caused by the Grounding of the MV Lake Triview**

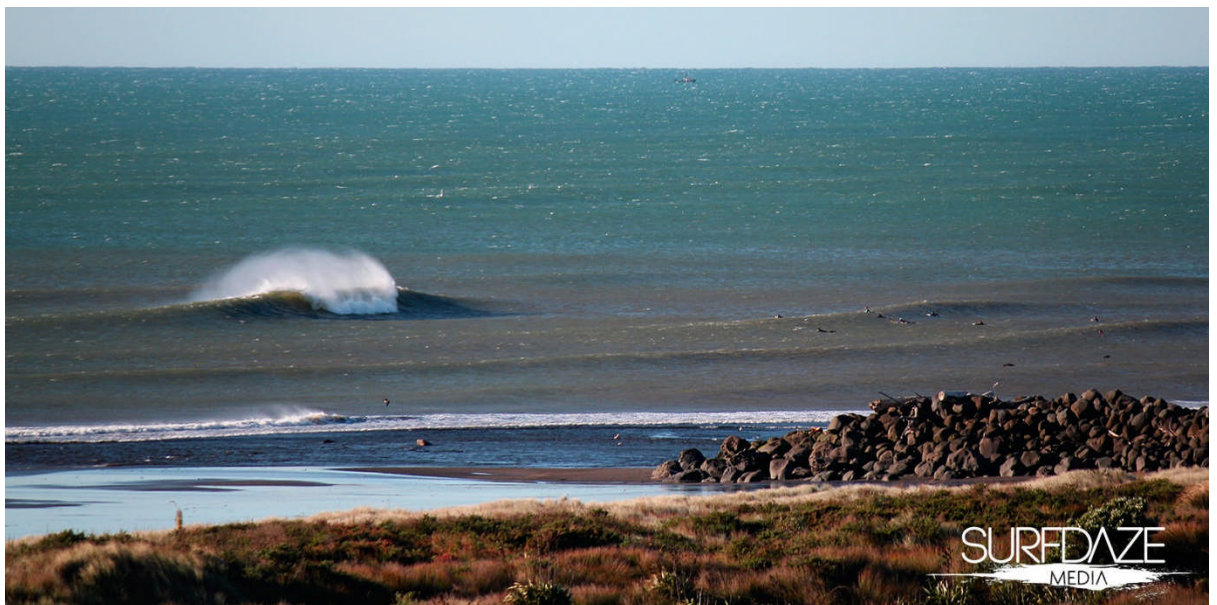
**Photo 1** Surfable wave at the Waiwhakaiho Surf Break March 2011

10. The surfable wave at Waiwhakaiho forms inshore and to the south east of where the MV Lake Triview ran aground (Photo 1).

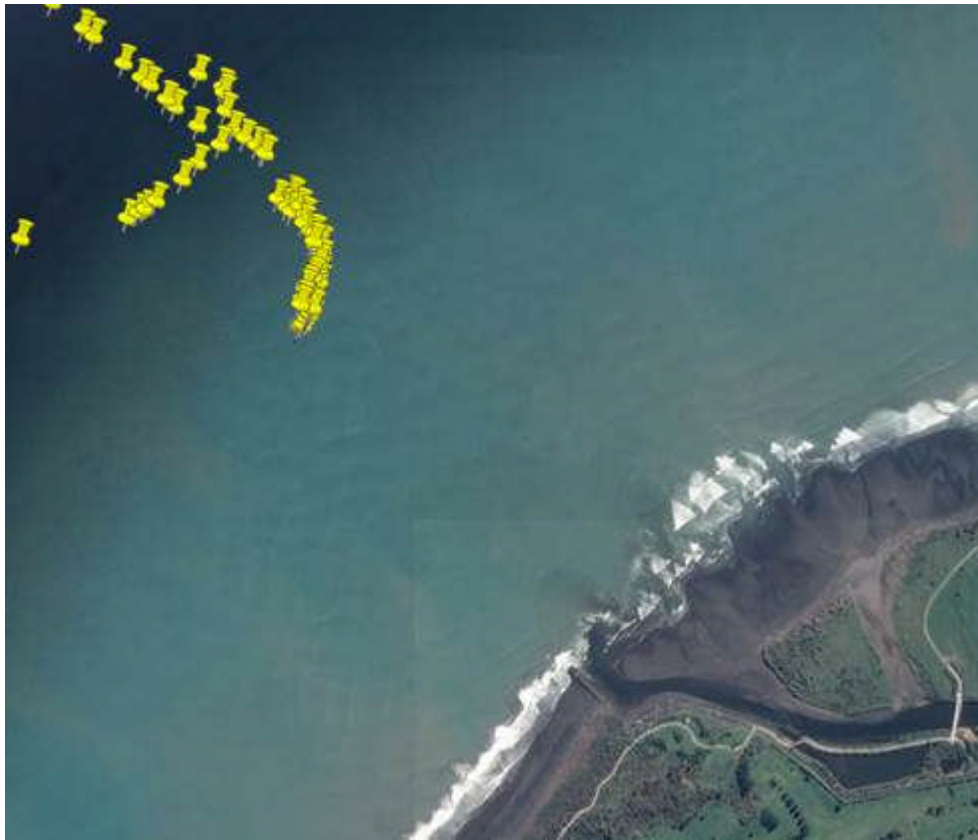
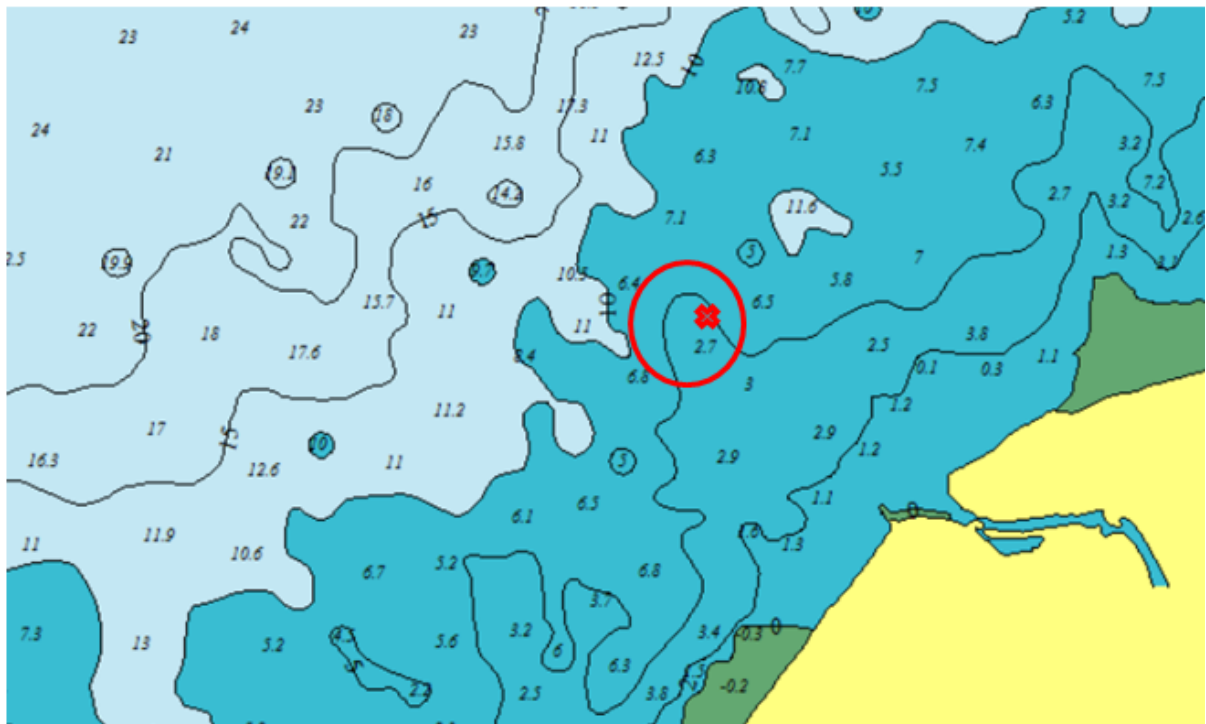
I have processed the position logs of the Lake Triview and attach them here as a Google Earth file, plus as an image below. The trajectory of the drifting vessel takes it directly over the Waiwhakaiho Reef, and the location where the vessel grounded appears to be on the eastern flank of the reef structure. The surf break at Waiwhakaiho lies inshore and to the SE of this location.

The reason there is a surf break at Waiwhakaiho is due to the shape of this offshore reef system. The reef concentrates wave energy through refraction and that energy is subsequently directed toward the break point just east of the river mouth. Note the protrusion of the 5 m isobath (circled in red) is directed into the swell direction, which enhances the refraction process. Without this reef shape there would not be the surf quality adjacent to the river mouth. In my opinion the grounding location coincides with the swell corridor for the surf break.
